# Manhole Inspection Summary

Manhole # S47KK\_001MH

Insp Date: **5/2/08 12:53 PM**

**Location** Address: **Collington Ave**

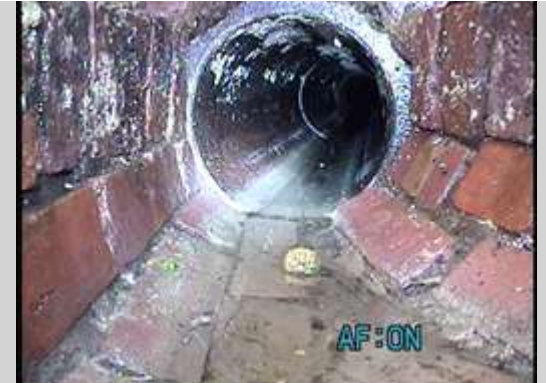
12 O'Clock Outflow

8 in. Circular Gravity Sewer  
Pipe Out @ 12 O'Clock

Pipe Height: **8.4** (in.) Rod and Bar (Angled)  
Pipe Material: **Clay** ☐ Pipe Lined  
Invert Depth: **9.90** (ft.) Flow Characteristics: **None**  
Deposits: ☒ None ☐ Mud ☐ Sludge ☐ Debris ☐ Grease  
Silt Depth: (in.) Deposits Extent:  
Infiltration: **None** Pipe Seal Cond: **Sound**

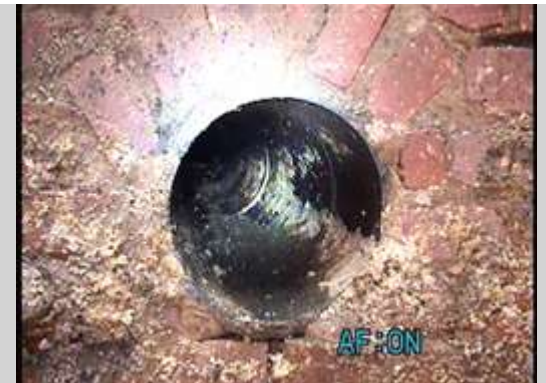
3 O'Clock Inflow

8 in. Circular Gravity Sewer  
Pipe In @ 3 O'Clock

Pipe Height: **8.4** (in.) Rod and Bar (Angled)  
Pipe Material: **Clay** ☐ Pipe Lined  
Invert Depth: **6.70** (ft.) Flow Characteristics: **None**  
Deposits: ☒ None ☐ Mud ☐ Sludge ☐ Debris ☐ Grease  
Silt Depth: (in.) Deposits Extent:  
Infiltration: **None** Pipe Seal Cond: **Sound**

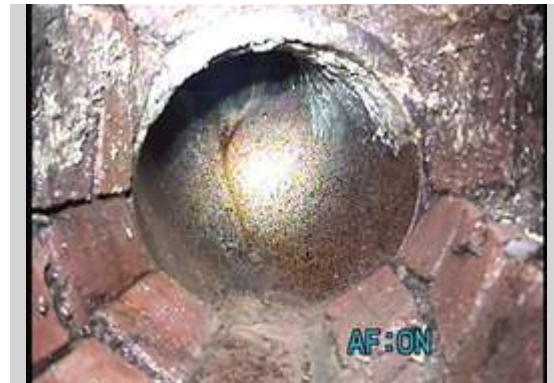
Drop In @ 3 O'Clock

Drop: **Outside** Rod and Bar  
Angled: **Yes** Reading: **8.80** (ft.)  
Inv Depth: **9.80** (ft.)  
Drop Condition: **Open**

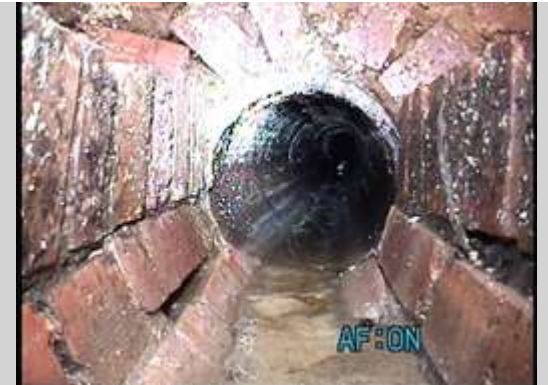
6 O'Clock Inflow

Pipe In @ 6 O'Clock

Infiltration: **None** Pipe Seal Cond: **Sound**
